### Technical information

Client: Municipio di Bellinzona  
 Architet: Enrico Sassi  
 Date: 2009 - 2011  
 Blacksmith: Lino Cattaneo, Defer Sagl  
 Photographer: Marcello Villada Ortiz

### Concept

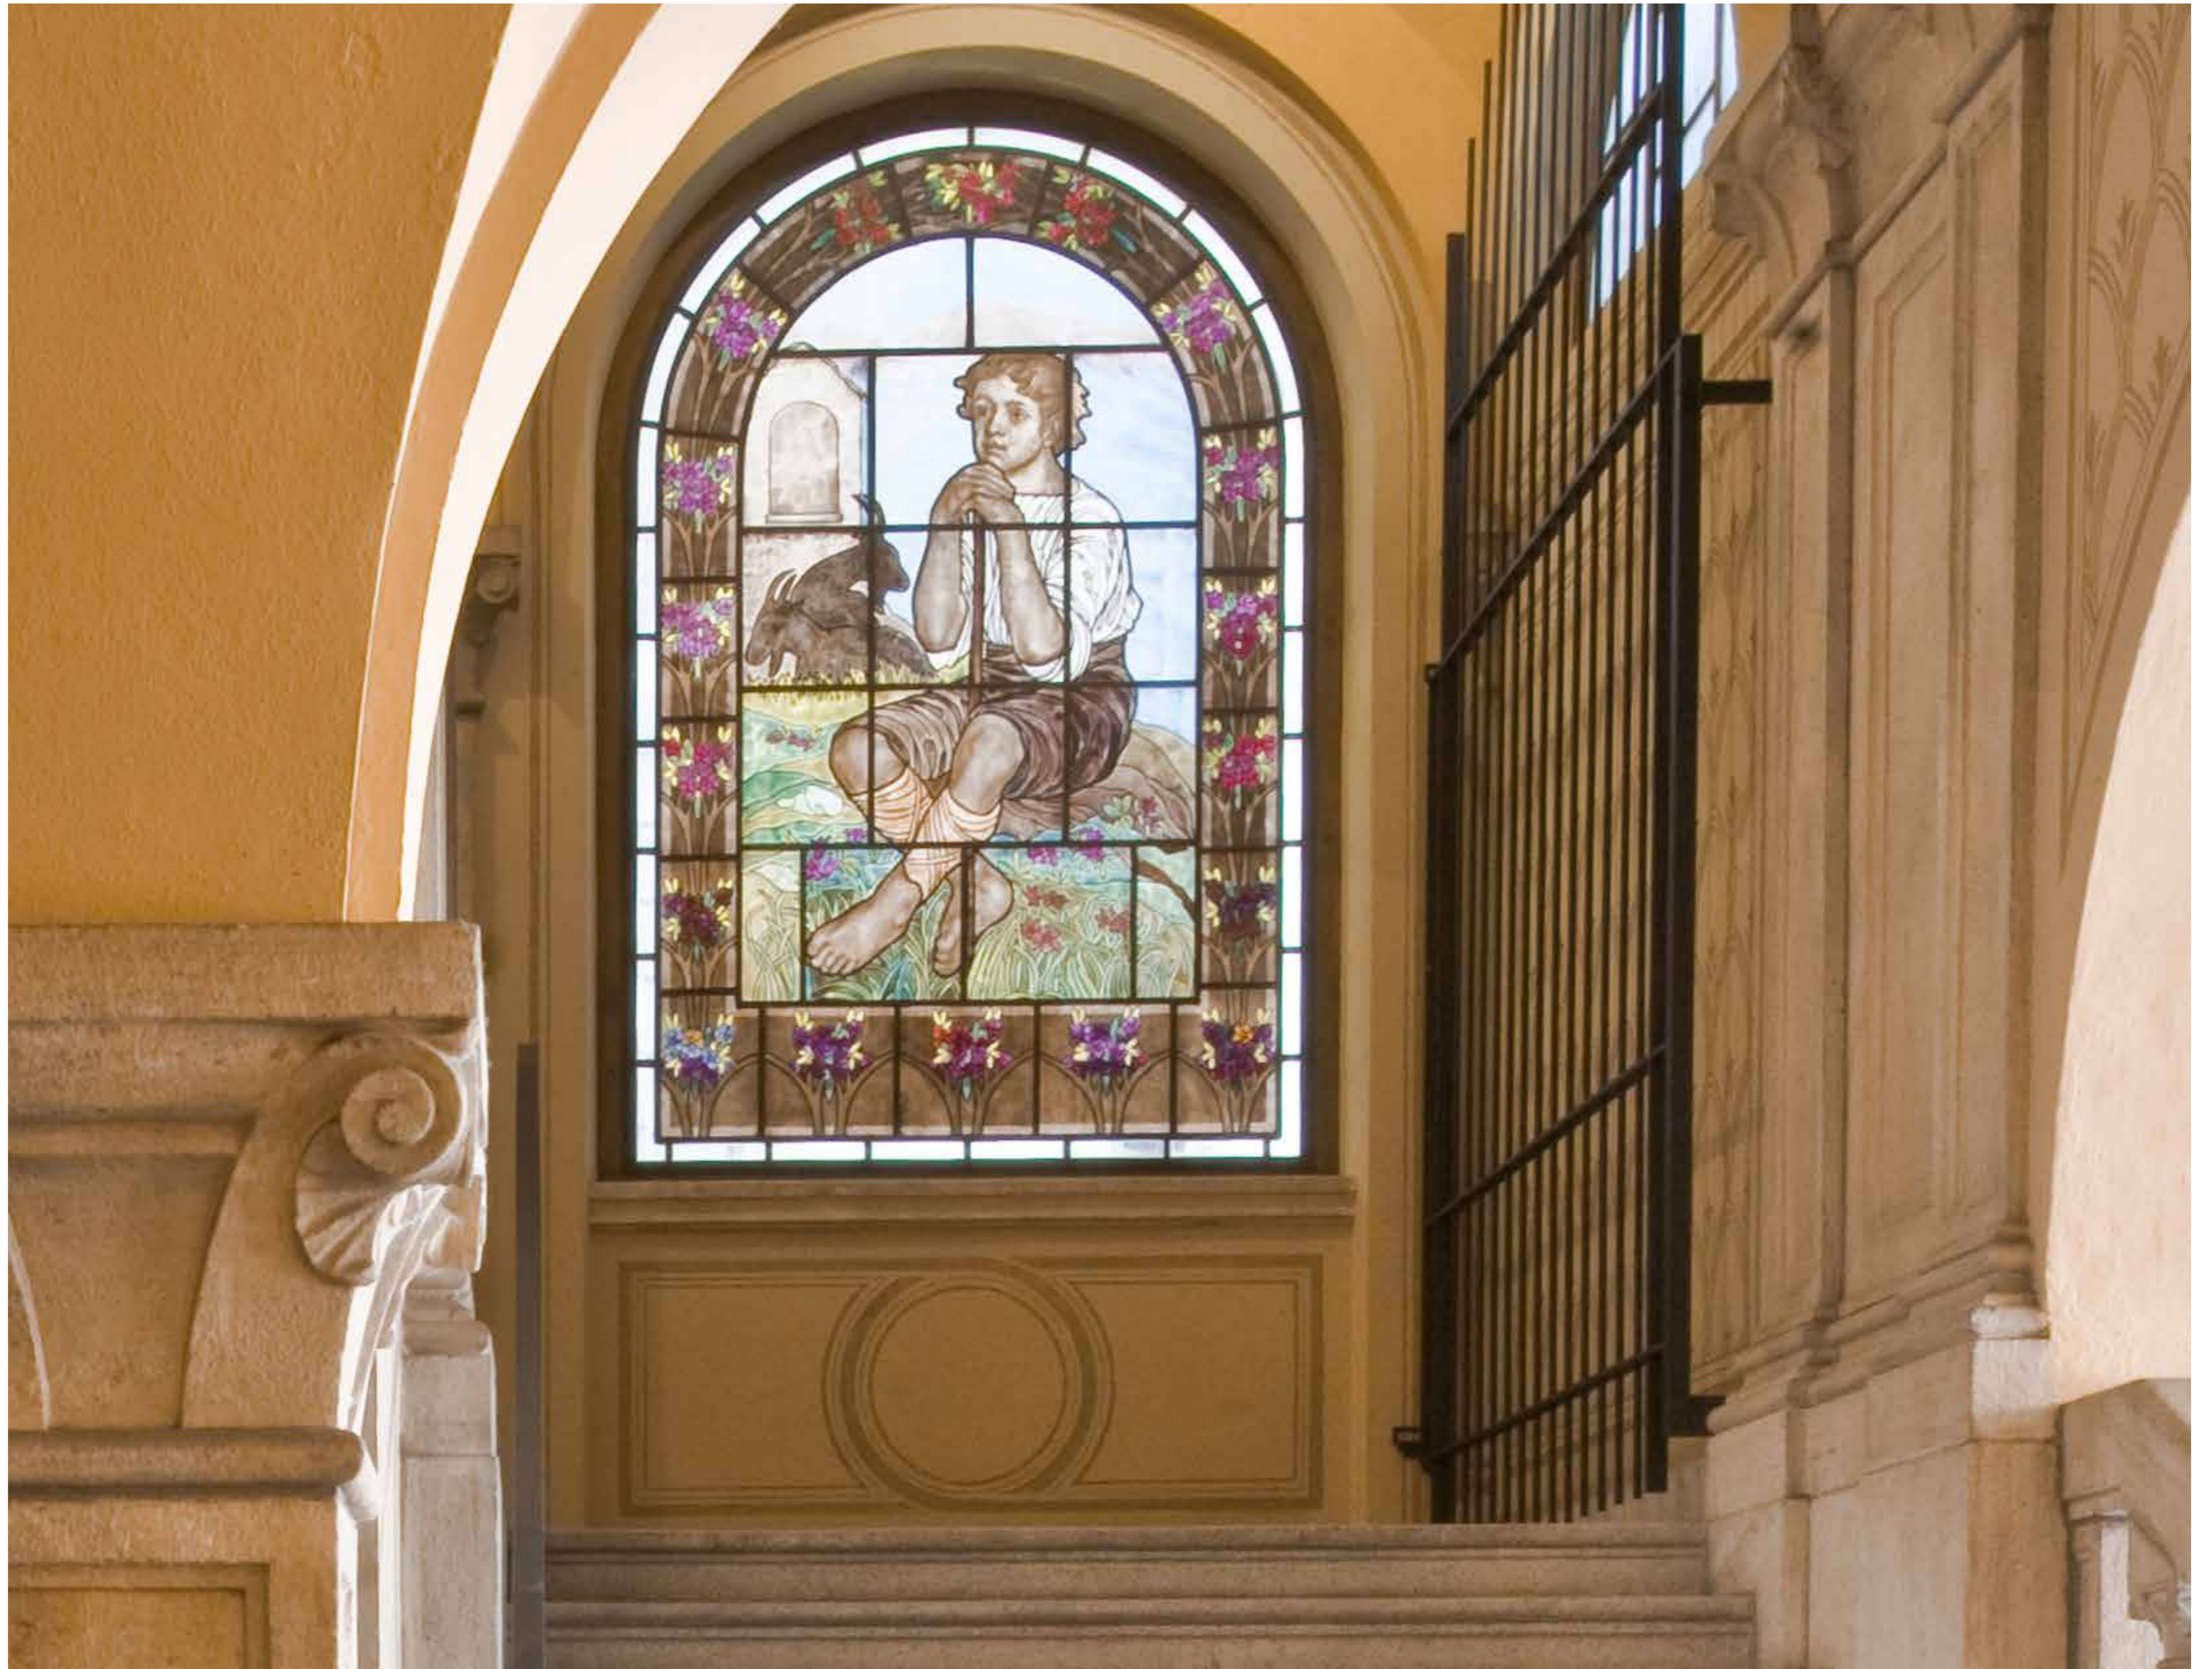
The project involves the construction of a gate that allows to physically separate the first floor from the ground floor of the municipal building.

The gate closes the hallway of the main staircase where the two windows of Augusto Sartori are located. With the gate closed, the windows are protected (well visible but not physically attainable). Access to the first floor is precluded.

The gate is located at the end of the first flight of stairs leading to the first floor

The new handrail also forms the gate knocker. The lock for closing is fixed on the vertical part of the handrail.

The brackets are stuck in the wall in such a position that they do not interact with the wall decoration. The gate is very transparent (15 mm diameter rods spaced of 13.5 cm) and allows, even when closed, the view of the rear window.

In the open position he approaches the wall overlapping the mural, its dimensions (194 x 194 cm) resume those of the wall decoration. The expected material is steel, 'oxidized-waxed' finish (brown color)
