### Technical information

Client: Città di Lugano – DSU – Spazi Pubblici  
 Architect: Enrico Sassi  
 Date: 2018 - 2021  
 Photographer: Simone Bossi, Marcelo Villada Ortiz

The Grotto della Roccia is a small historic building, which has been out of use for almost a century, set in the rock at the beginning of the Gandria path and overlooking Lake Lugano.

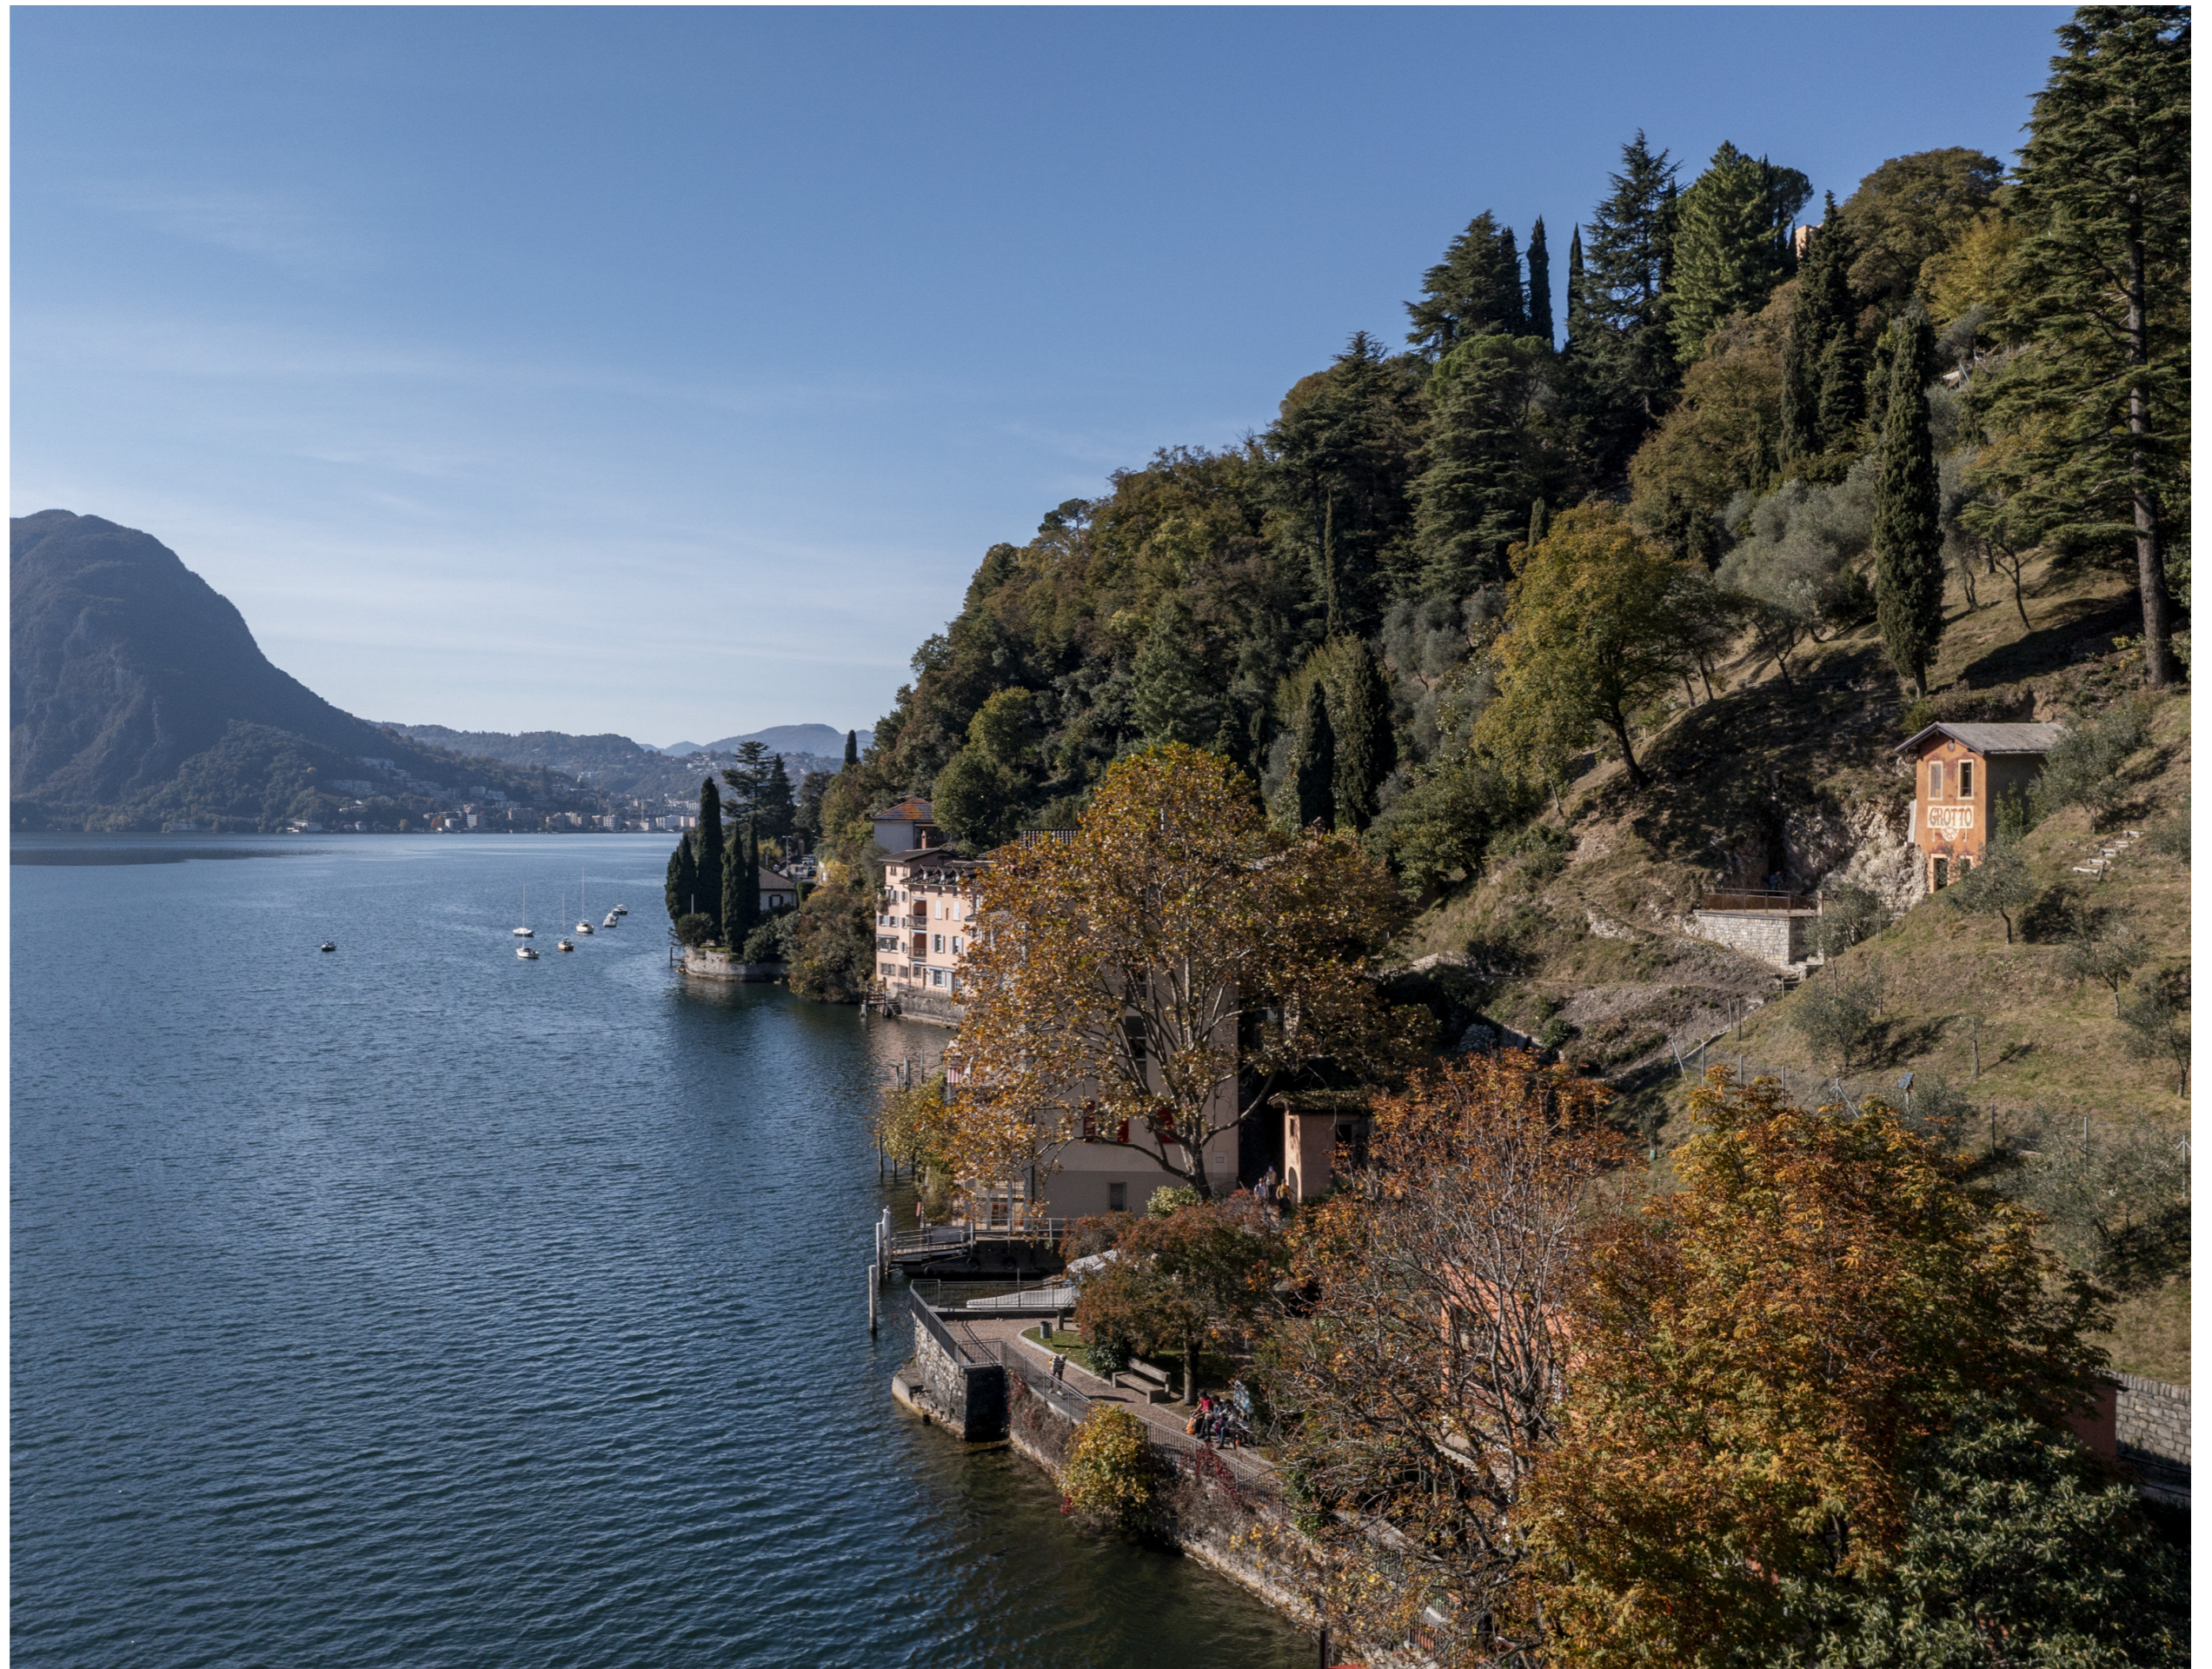
The back wall of the original building was removed to gain space for the construction of the exposed concrete staircase, thus adding more rock surface to the interior of

the building. Two new reinforced concrete walls and a new reinforced concrete slab were then built, which in addition to covering the new connection further consolidated the original building by connecting it entirely to the rock behind.
