Technical information

Client: Città di Lugano - DSU

Architect: Enrico Sassi

Date: 2020 - 2023

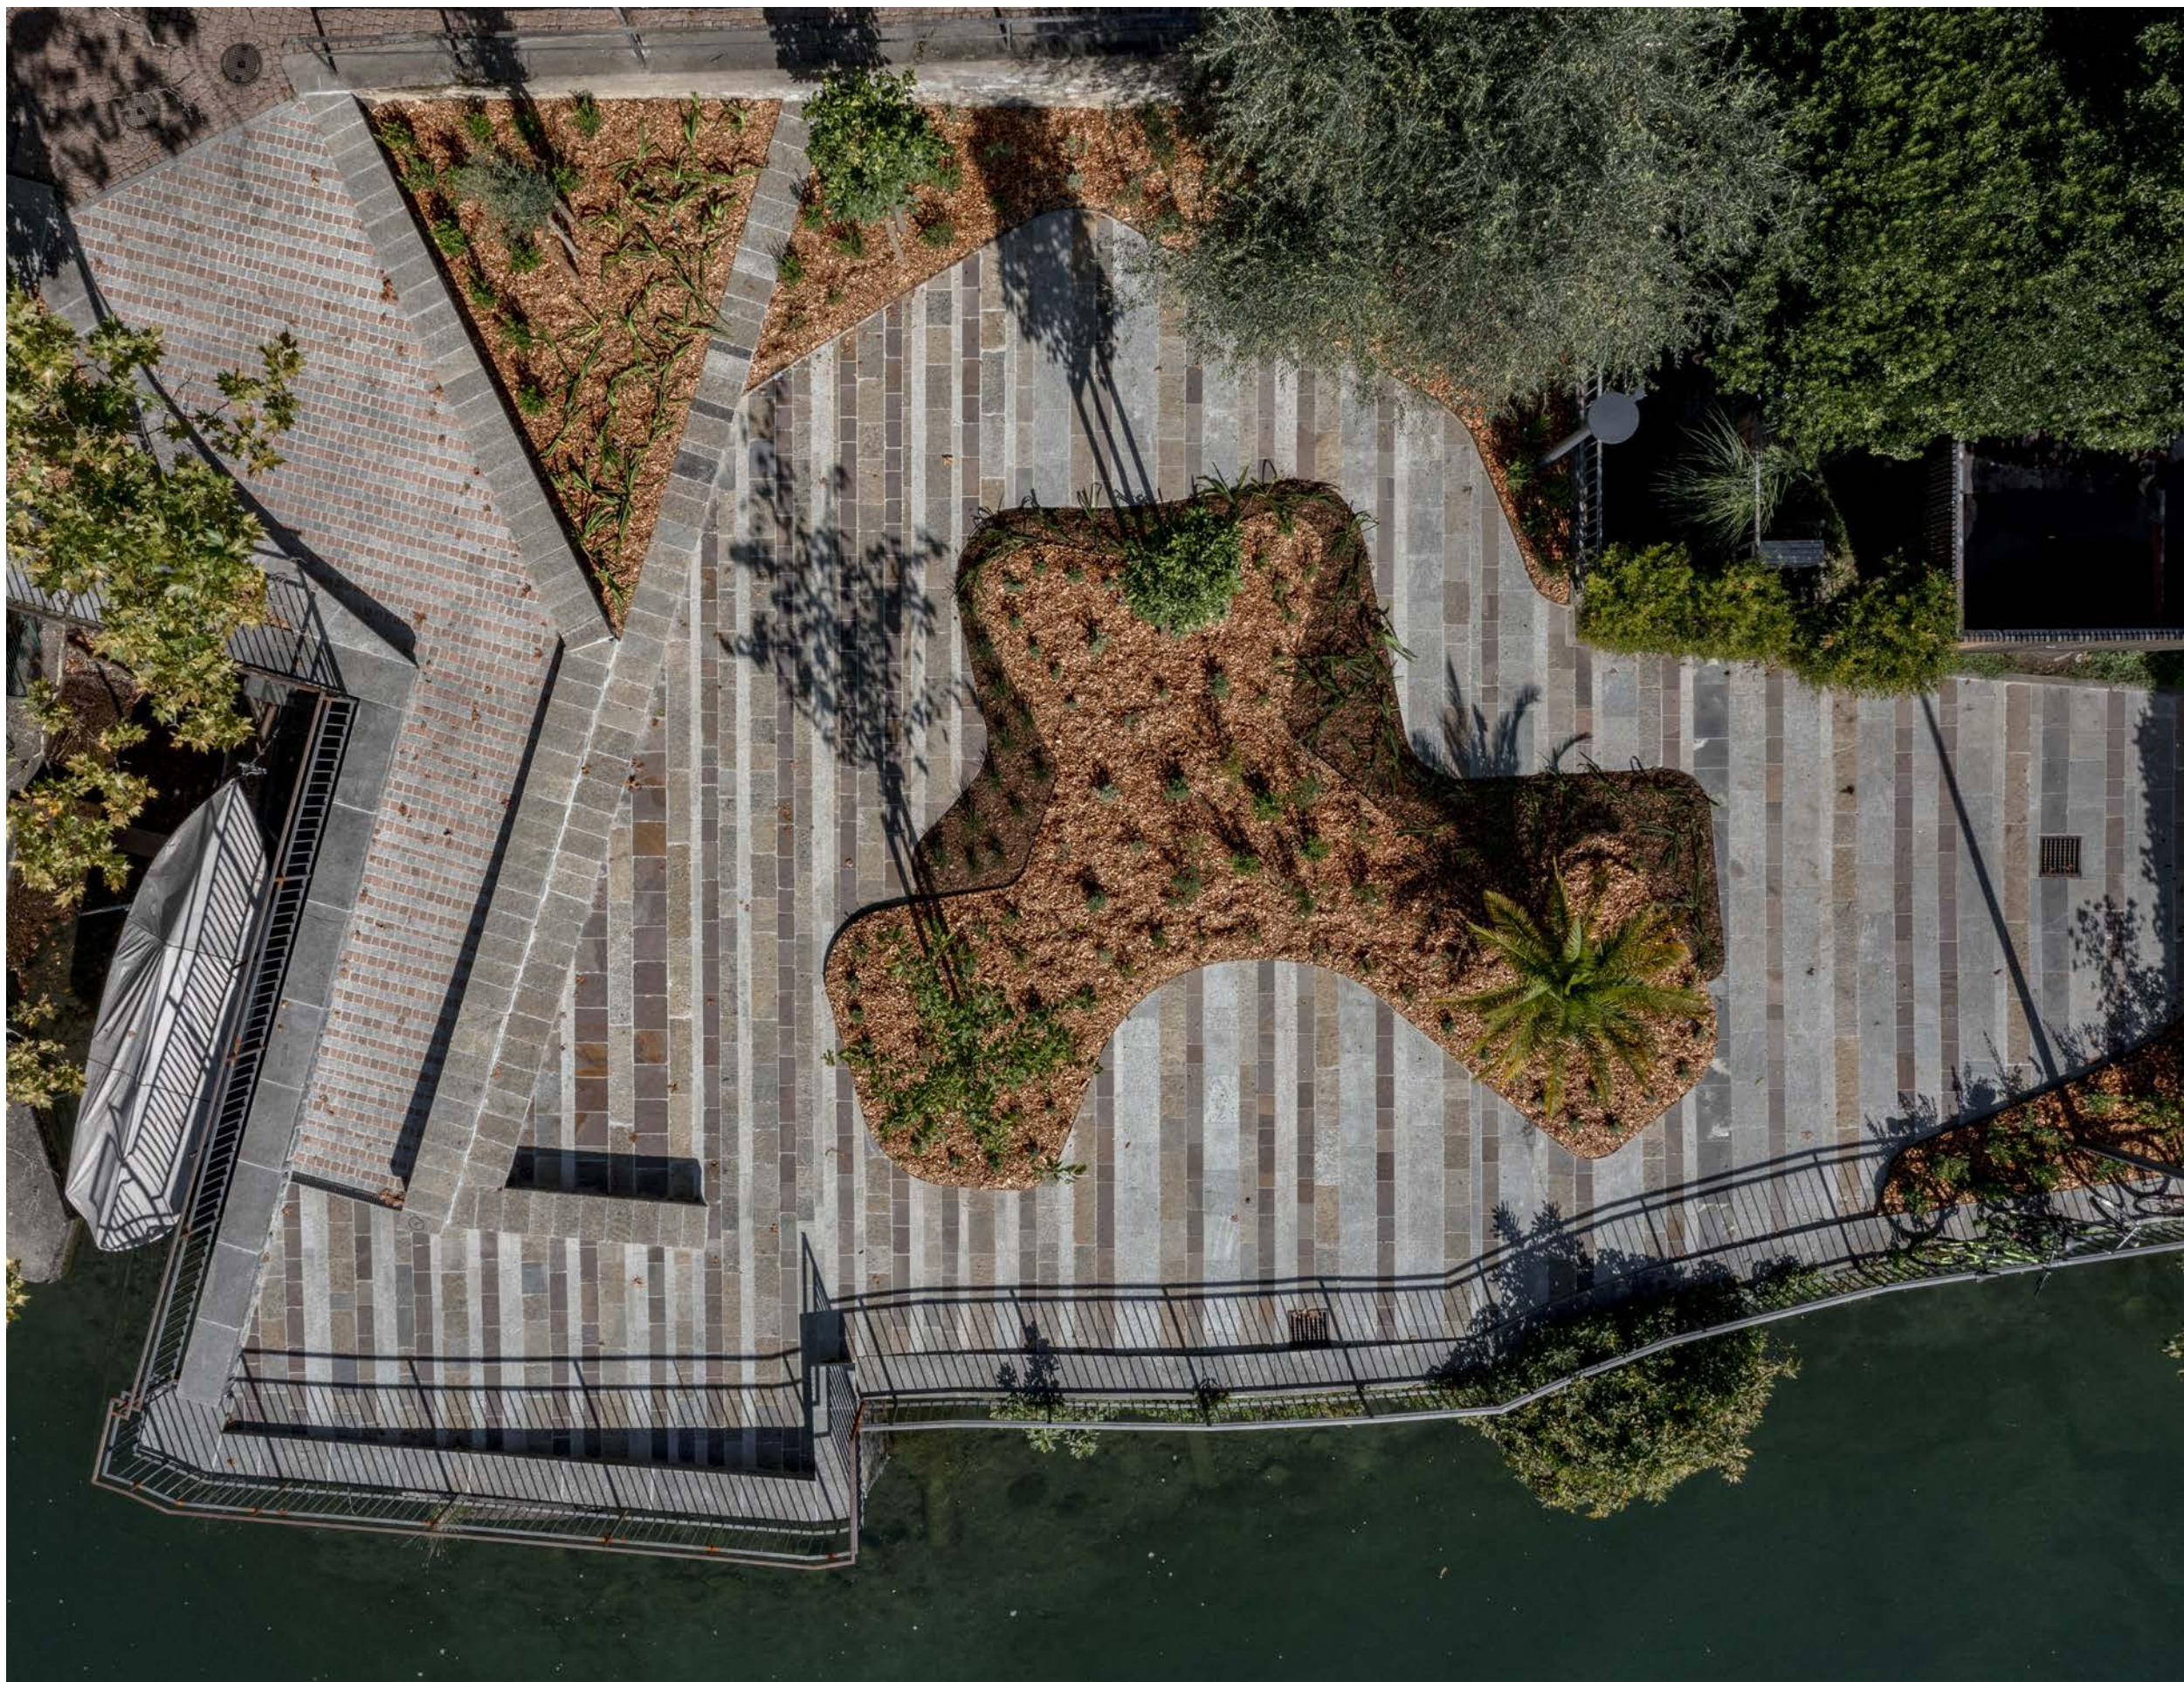
The access square to the lido has been redesigned through a play of colours, materials and curves. The new access is via a ramp with a 6% gradient, the ramp opens towards the lake landscape and directs the visitor's gaze towards various glimpses and views. On the side of the ramp a system of steps was built in Calcare di Moltrasio (Sasso di Caprino) on which it is possible to sit and admire the landscape. In the center of the square there is a large flowerbed with a sinuous shape inside which three different trees are planted, a *Fraxinus Ornus*, a *Morus Alba* 'Fruitless' and a *Phoenix Canariensis*. In the shade of the trees, "spots" of different essences are planted, one of Mediterranean perennials (*Perovskia atripicifolia*, *Phlomis fruticosa*, *Lavandula angustifolia* "Hidecote Blue", *Rosmarinus officinalis*, *Cistus salviifolius*, *Myrtus communis*

“Tarentina”, *Sedum telephium*), one of *Agapanthus africanus* and one of *Thulbagia violacea*. All the flooring is made with reused stone from the deposit of the City of Lugano, laid in stripes with alternating colours.

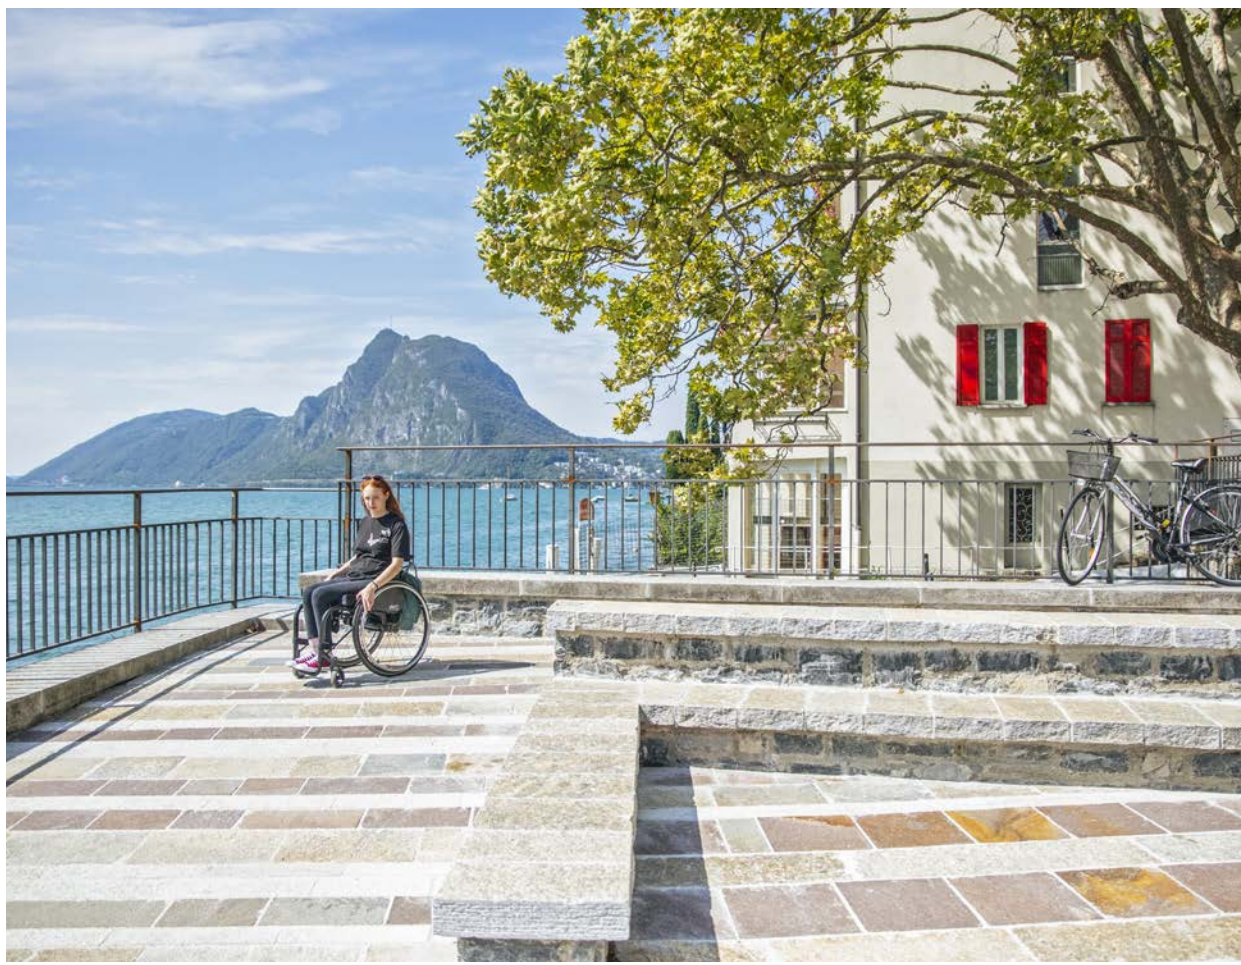
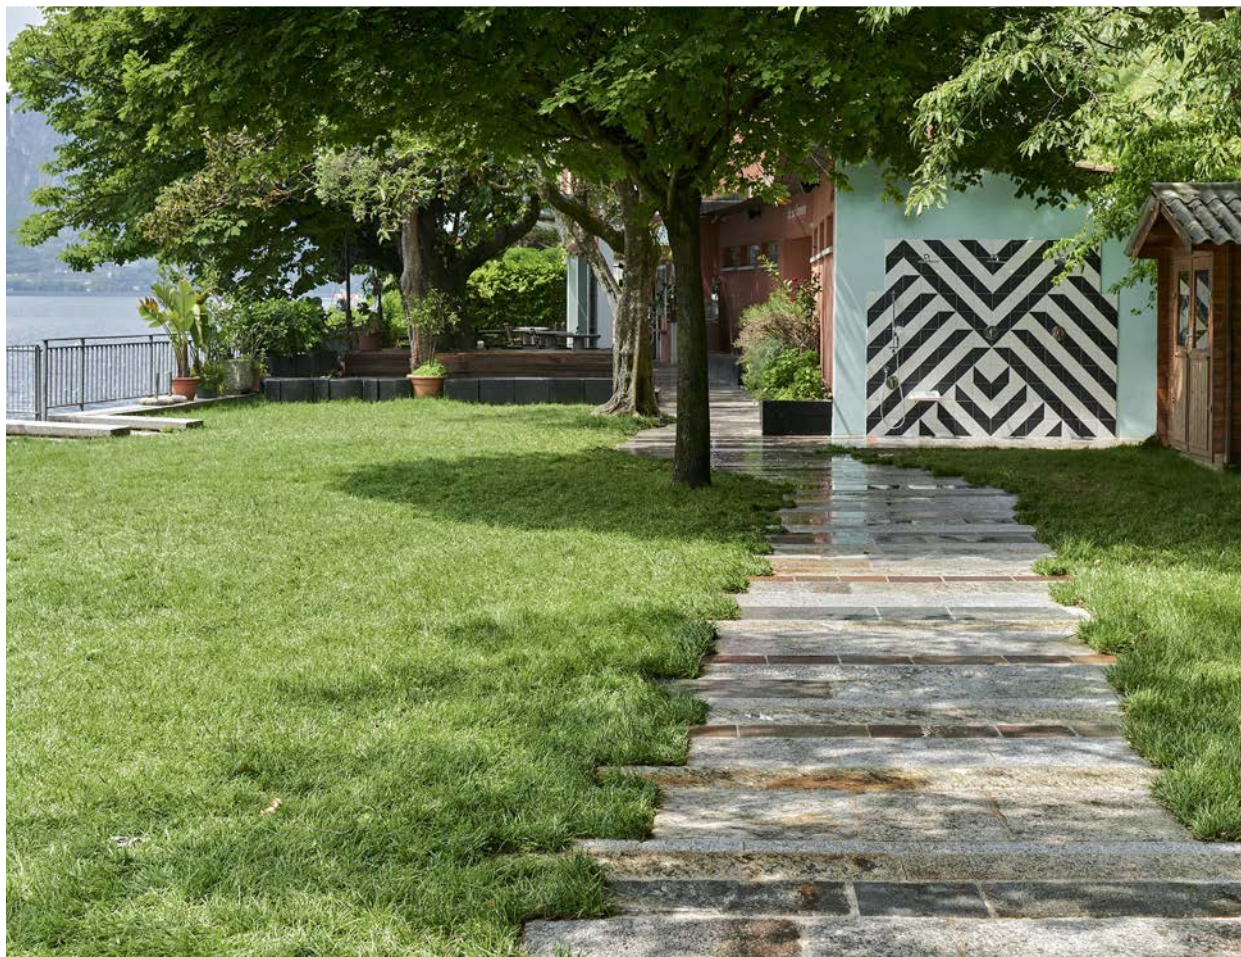
The square leads to Lido San Domenico, the project envisages the continuation of the paving of the square also inside the lido, with the construction of a path paved in precious stone that connects the entrance to the lido, the de hors, the changing rooms, the outdoor showers, up to the descent into the water system for people with disabilities, which takes place with the aid of a stair lift and a hydraulic lift. The descent system to the lake is located at the end of the lido, the existing quay covered with wooden planks was paved with large slabs of recycled stone on which the hydraulic lift was installed. The stairs that connect the level of the lido to that of the quay were paved with porphyry cubes from Cuasso al Monte and equipped with a stair lift.

Two bathrooms for the disabled have been created inside the changing rooms. The existing external showers have been modified to be usable by disabled users, the tub that served as a shower tray has been demolished and replaced by coplanar stone flooring, and a new water point with seat has also been created. The black and white tile covering that decorates the wall was rebuilt with a similar design to the pre-existing one.

The outdoor area was located at a higher level than that of the entrance and covered with concrete tiles, with the new intervention the existing flooring was removed and the level of foot traffic lowered bringing it to the level of the entrance, the new flooring is was created by integrating the existing tables.
